Subject: Addendum Report

Results of Additional Subsurface Fault Investigation

Lot 46 of Tentative Tract 37-46, White Mountain Estates Subdivision

Chalfant Valley, Mono County, California

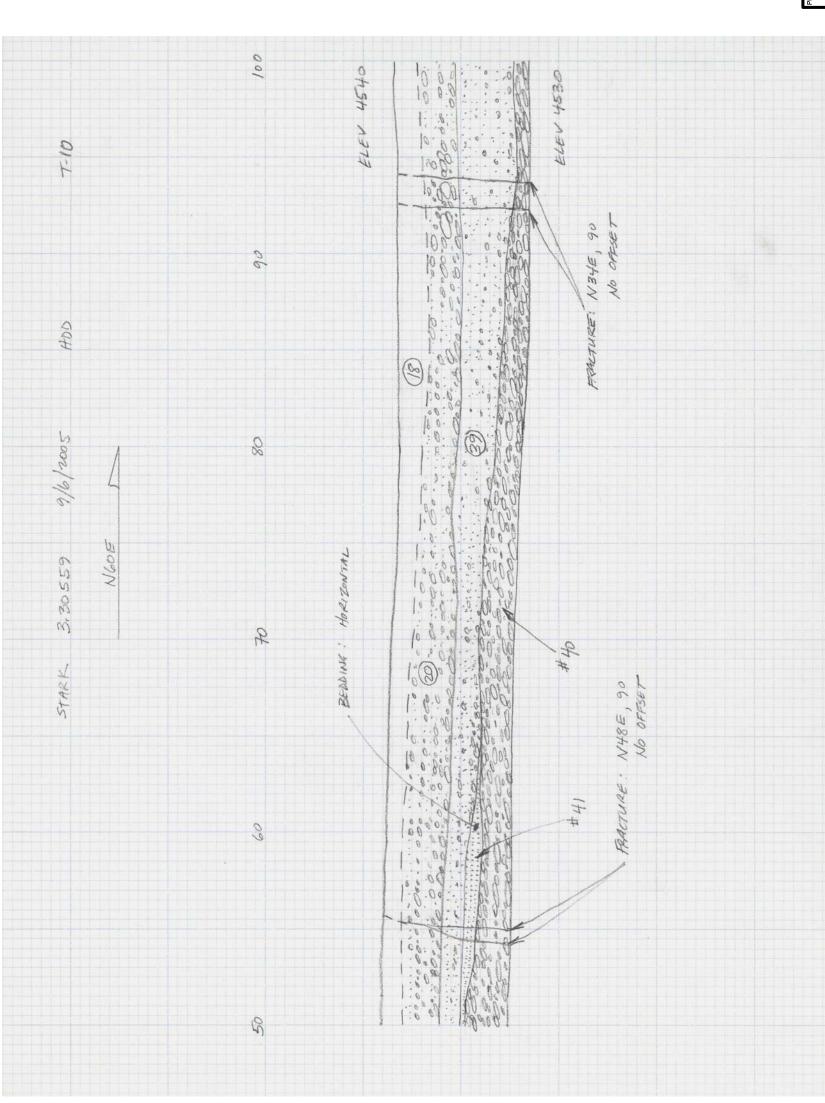
The stratigraphic units exposed in Trench T-10 did not indicate any faulting, but instead exposed laterally continuous, horizontally stratified younger deposits that overlay an older, moderately-inclined cobble conglomerate unit in the shutter-ridge to the west. These younger deposits appear consistent with those previously exposed in Trench T-6 to the north, particularly Units 18, 20, 39, 40 and 41, and the older cobble conglomerate deposit appears consistent with Unit 31, also exposed in Trench T-6. Minor cracks with no apparent offset were found in the younger deposits trending N 34° to 48° E. The contact between the younger and older units appears conformable and exposes well-preserved depositional features, such as imbricated shale clasts along the base of Unit 40 that appeared to be at least partly derived from the older cobble conglomerate Unit 31. Unit 41 is overlain by Unit 40, and it also appears to be derived from Unit 31.
